Power Source Voltage Drop/Voltage Rise

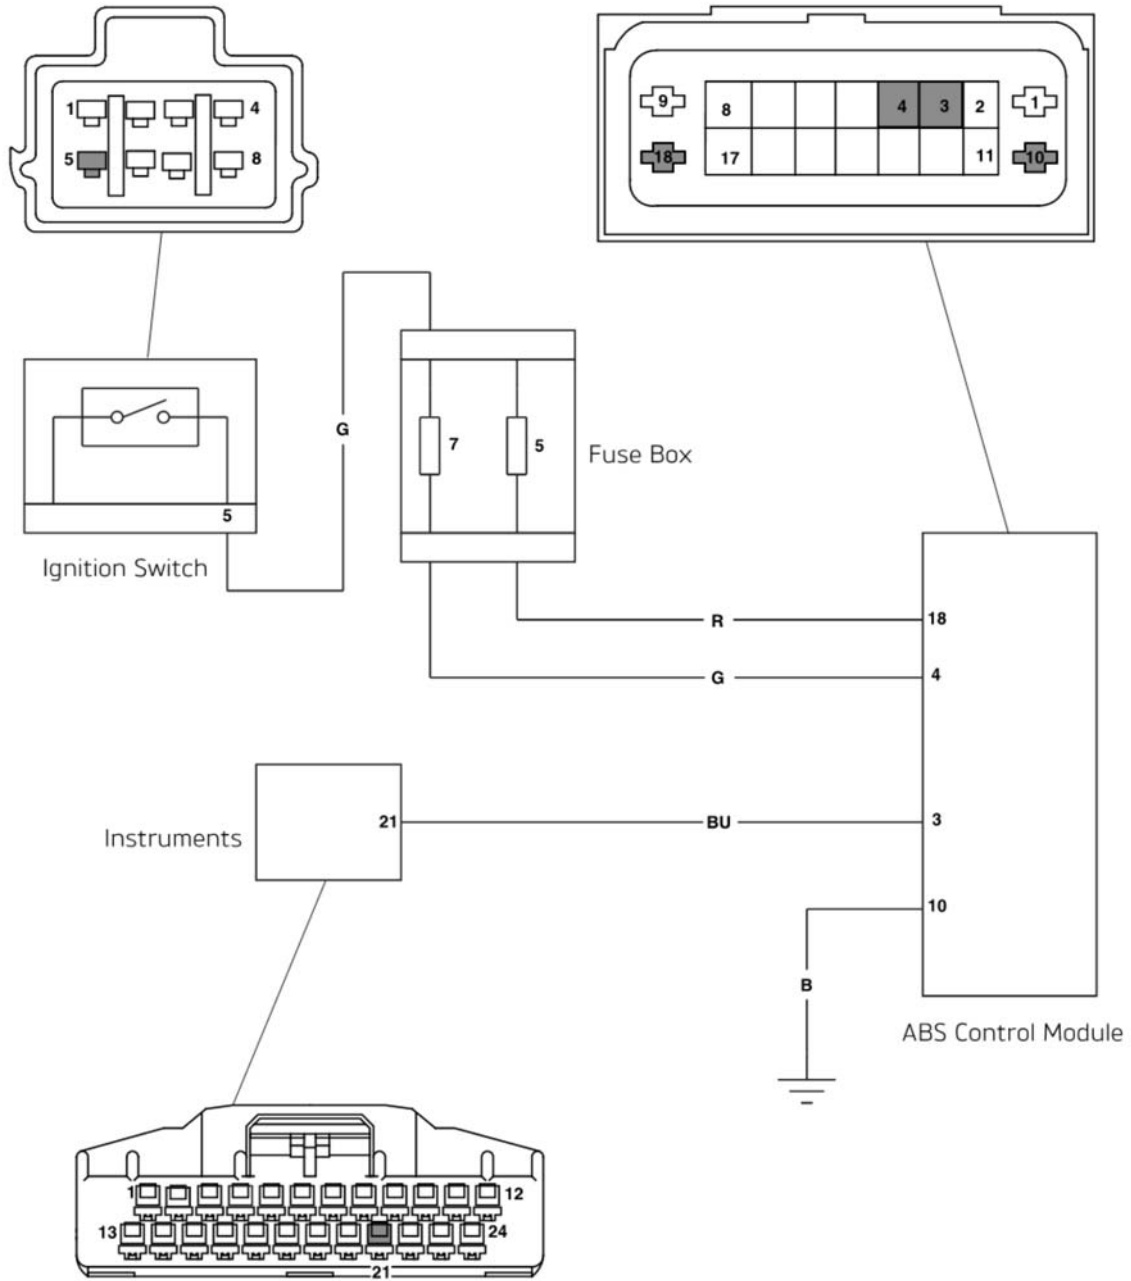
Circuit Diagram

Fault Code	Possible cause	Action
C1661;	Power source voltage too low	Ensure ABS ECM connector is secure.
C1662	Power source voltage too high	Disconnect ABS ECM connector and proceed to pinpoint test 1:

Test	Result	Action	
1	Check cable and terminal integrity: - ABS ECM connector pin 4 and ground pin 10	OK	Proceed to test 2
		Faulty	Rectify fault, proceed to test 5
2	Check the cable for continuity: - ABS ECM connector pin 10 and ground	OK	Proceed to test 3
		Faulty	Rectify wiring harness fault, proceed to test 5
3	Check battery voltage: With ignition 'ON', check the voltage between: - ABS ECM connector pin 4 and ground pin 10	Voltage greater than 11 V	Proceed to test 4
		Voltage less than 11 V	Locate and rectify fault, proceed to test 5
4	Check battery voltage: Reconnect ABS ECM connector and start the engine, check the voltage between: - Battery positive (red) terminal and negative (black) terminal	Voltage between 11 V and 16 V	Proceed to test 5
		Voltage greater than 16 V	Check the battery charging circuit. Locate and rectify fault, proceed to test 5
5	Clear fault code and test ABS to verify fault cleared.	OK	Action complete - quit test
